PROPERTY INSPECTION REPORT

Concerning: 1000 Example St., Houston, Texas
(Address or Other Identification of Inspected Property)

By: Robert Waitschies TREC#5814 4/1/2009
(Name and License Number of Inspector) (Date)

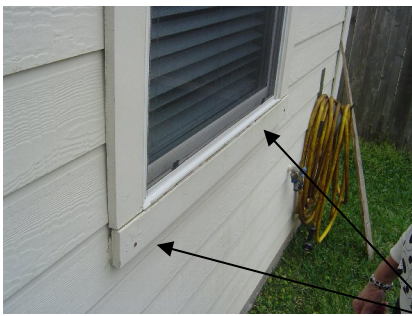
E. Walls (Interior & Exterior) *Comments:*

- Minor cracks were observed on the interior walls of the home. This condition is mainly cosmetic in nature and should be patched.
- Brick and fiber cement exterior veneer was observed.
- It is recommended that all exterior wall penetrations should be sealed.
- Vegetation is contacting the exterior walls of the home. At least 6 inches clearance from exterior walls is recommended.
- Weep holes (openings in the mortar joints) were not present above the lintels (metal headers) in the brick veneer wall.
- The exterior window trim at the kitchen window is loose.

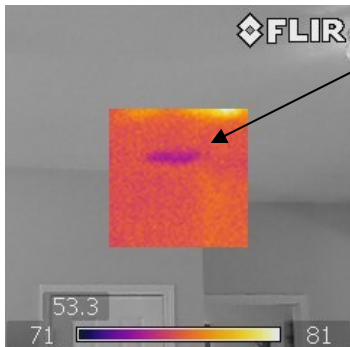
F. Ceilings & Floors *Comments:*

- Carpet, vinyl and tile flooring was observed.
- 40% moisture was observed on the game room ceiling (above the closet door). An attic vent was observed above this area and may be caused by a recent rainstorm. Further investigation is recommended. (See infrared image)
- Water staining was observed at the kitchen ceiling above the backdoor. Further investigation is recommended
- Minor settlement cracks were observed on the vaulted ceilings within the home. This condition is mainly cosmetic.
- Evidence of patching and cracking was detected on the upper right rear guest bedroom ceiling. The furnace vent pipe appears to be above this area. Further investigation is recommended.

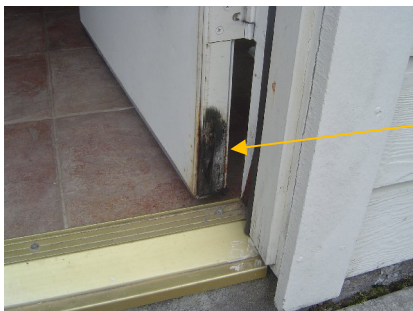
G. Doors (Interior & Exterior) *Comments:*

- The front door is splitting.
- The laundry room door did not latch properly.
- It is recommended that door stops be installed at all doors to prevent damage to the walls.
- The backdoor has sustained water damage on the inside jamb. Repairs or replacement of the door is recommended to ensure proper operation of the door.
- The upper left front guest bedroom door did not latch properly.

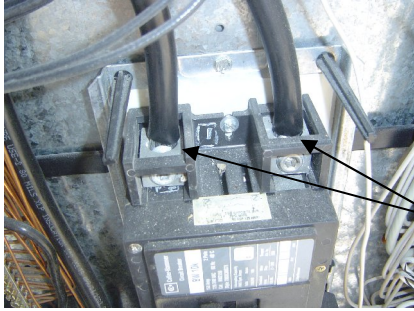
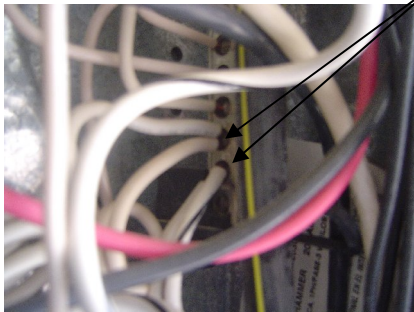
A. Service Entrance and Panels *Comments:*

- Cutler Hammer Brand, 150amp electrical service panel located in the garage.
- Today's electrical standards require Arc-fault (AFCI) breakers on all general circuits within the home that are not GFCI protected. Recommend updating to today's standards.
- The grounding of the electrical service is not to the current electrical standards. Updating to the current standards by installing a secondary earth ground to a second ground rod or rebar (UFER) is recommended.
- Antioxidant mastic was not present at the aluminum main service feed wires. In an effort to prevent oxidation it is recommended that antioxidant mastic paste be applied.
- Neutral wires within the main distribution panel that are bunched together on the neutral bus bar should be separated. Each wire should be served by a separate screw.

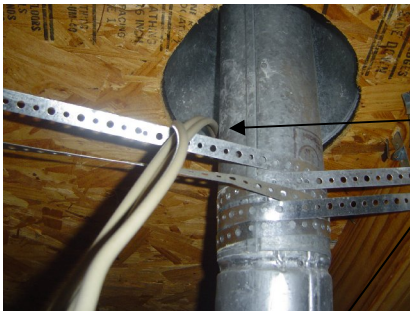
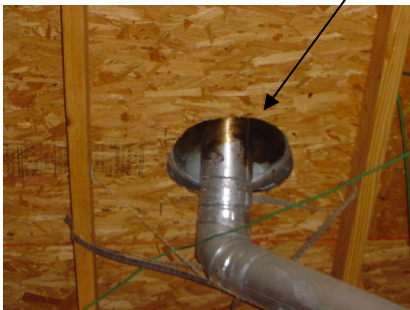
A. Heating Equipment

- Two systems serving the upper and lower floors
- Two Carrier Brand gas furnaces were observed in the attic.
- Both units appeared to operate and vent properly at time of inspection.
- Wires are contacting the furnace flue and should be moved to allow the proper one inch clearance from all combustible materials.
- It appears that a tar like material was applied to the furnace vent pipe at the roof penetration. This area may leak when it rains. A one inch clearance from all combustible materials should be maintained. Repairs should be undertaken. (Evidence of patching or cracking was observed on the bedroom ceiling below this area).

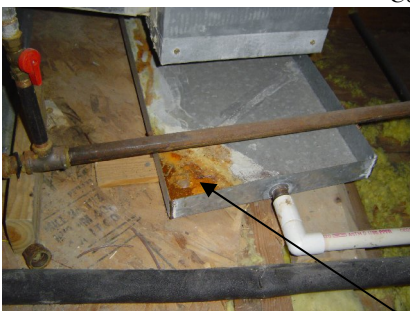
B. Cooling Equipment

- Two zone system serving the upper and lower floors
- Carrier Brand, model # 38BRC036330, 3 TON compressor was observed on the right side of the home.
- Carrier Brand, model # 38BRC030310, 2½ TON compressor was observed on the right side of the home.
- The unit serving the lower level operated and produced a supply temperature of 53 degrees and a return of 66 degrees. This is not within proper operation limits of 16 to 21 degrees. Recommend unit be serviced by a HVAC technician.
- The unit serving the upper level operated and produced a supply temperature of 50 degrees and a return of 68 degrees. This is within proper operation limits of 16 to 21 degrees.
- Rust was observed in the auxiliary drain pan below the unit in the attic.
- Vegetation around the outdoor units of the air conditioning systems should be removed or cut back to allow proper operation of the cooling system.

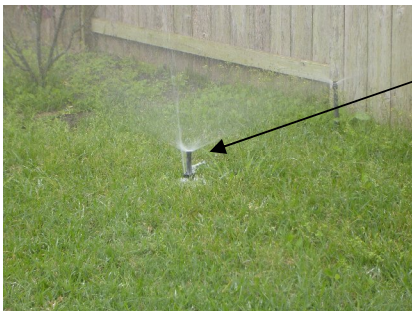
A. Lawn and Garden Sprinkler Systems *Comments:*

- Hunter Brand 8 zone lawn sprinkler system was operated in manual mode only.
- A damaged head was observed in zone # 6 in the backyard.
- Ideally water spray from the sprinkler system should be re-directed away from the structure and/or any fencing, decks, etc., to decrease the possibility of damage.
- A rain sensor was not observed.
